REPAIR & REPLACEMENT RESERVE REPORT

THE PORTER, INC.
3600 Connecticut Avenue, N.W.
Washington, D.C. 20008

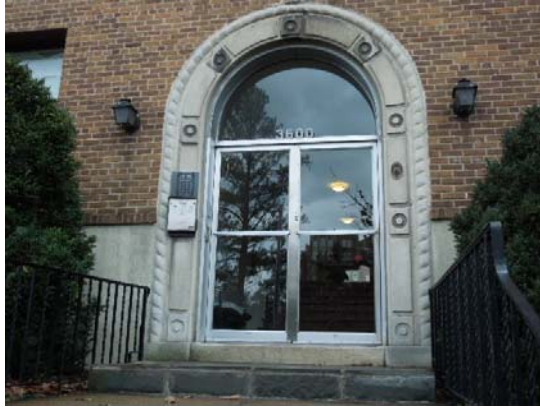
Prepared For:
Board of Directors
The Porter, Inc.
c/o: Ms. Rebecca Clark
EJF Real Estate Services
1428 U Street, N.W.
Washington, D.C. 20009

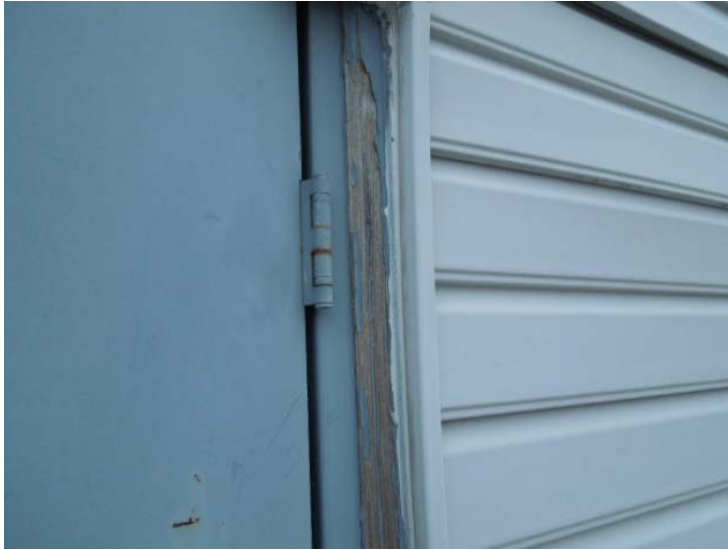
Photo #1: The “roof” access stairwell penthouse is in need of some exterior paint. We recommend this be maintained to prevent the wood from rotting.

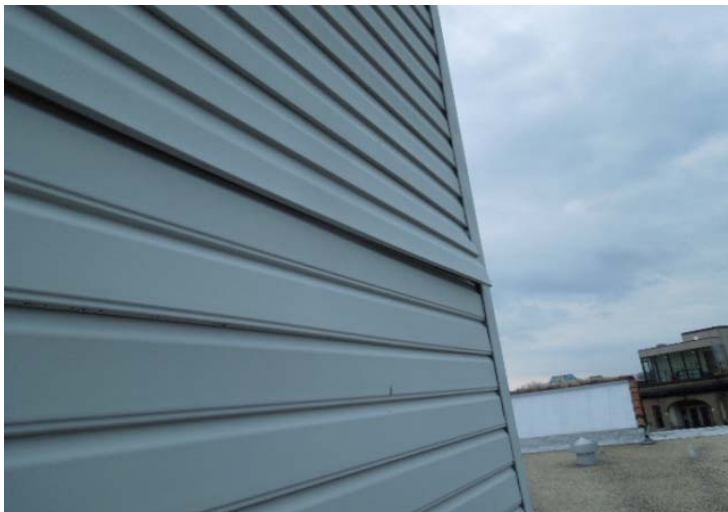
Photo #2: This is one of several areas on the stairwell penthouse roof where the vinyl siding needs repair. We recommend this be done to prevent further damage.

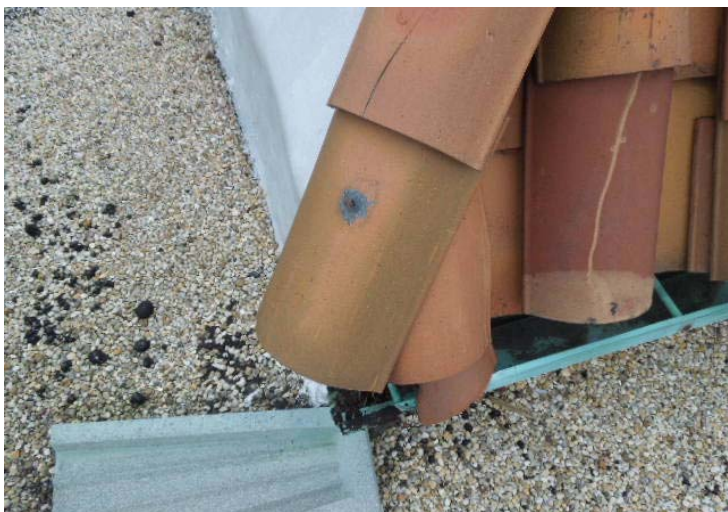
Photo #3: Some nails are backing out of the roof tiles. Some roof tiles are cracking. We recommend these be attended to so that tiles do not come loose and harm passersby and to minimize further damage.

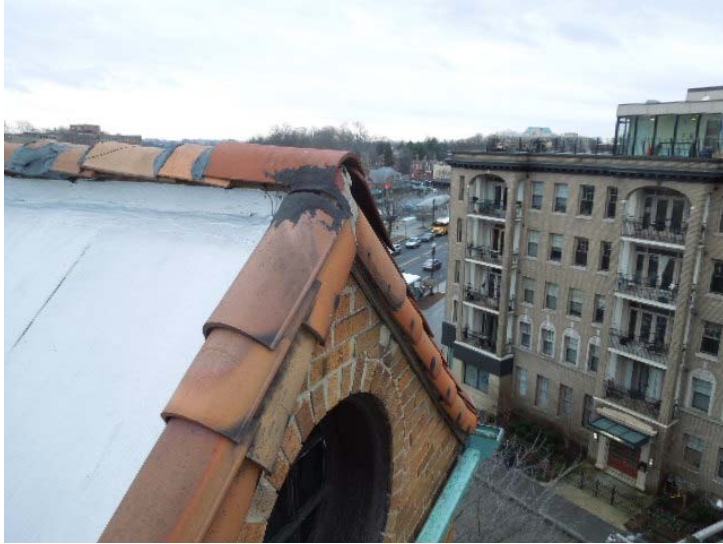
Photo #4: Cap tile is cracked. Tile sealant has deteriorated on west side gable cap.

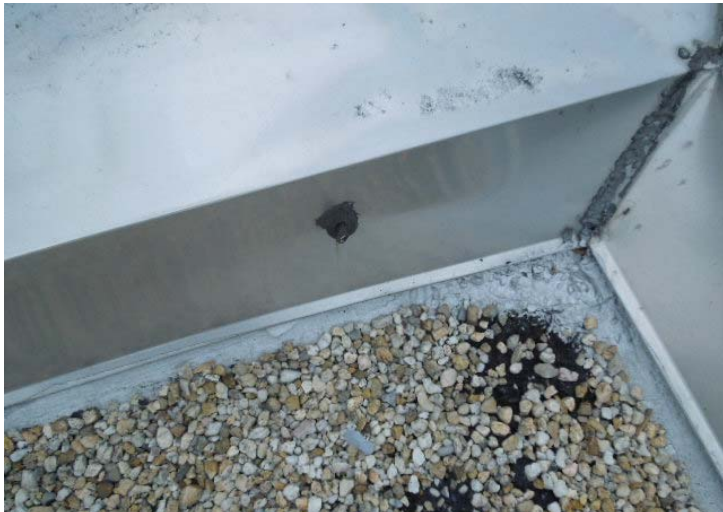
Photo #5: Nails backing out of cap flashings should be secured and caulked to maintain the seal and prevent further damage.

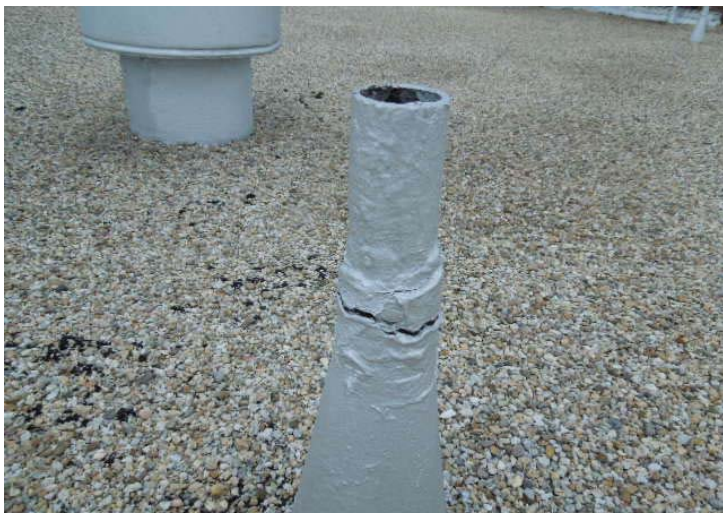
Photo #6: Vent flashing sealant has deteriorated. This can allow water to follow the outside of the piping into the building. We recommend these flashings be sealed.

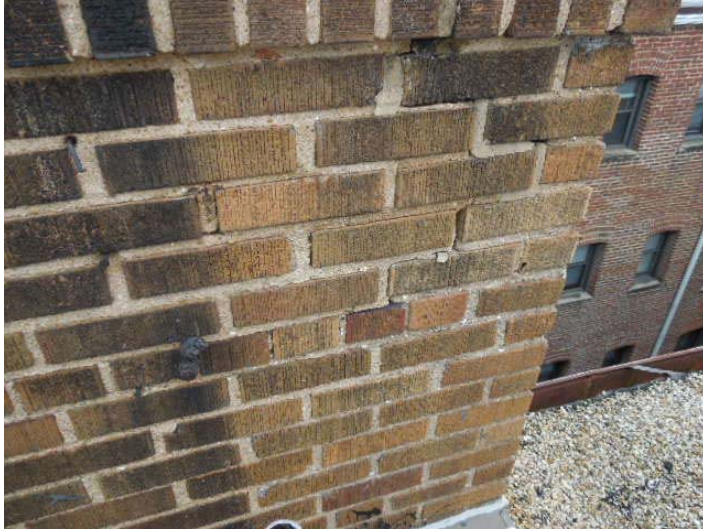
Photo #7: Point work failing and cracking on chimney. This could be latent earthquake defects. We recommend this be pointed and sealed to prevent further deterioration.

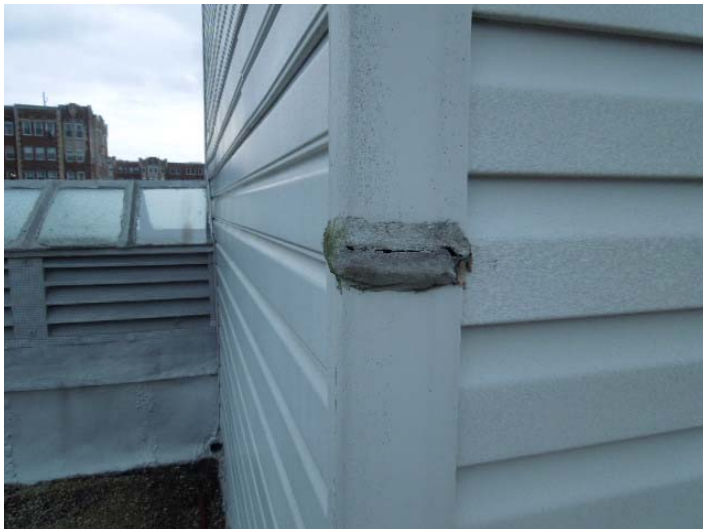
Photo #8: Caulk is failing on vinyl siding of penthouse. We recommend this caulk be replaced.

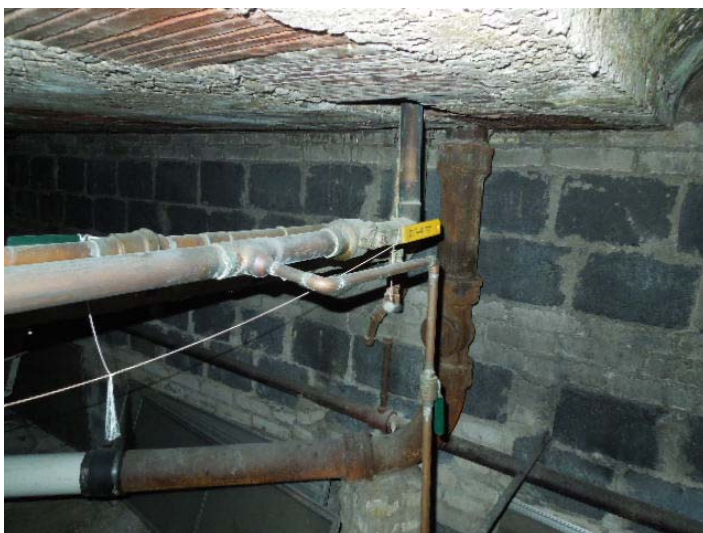
Photo #9: Typical ball type isolation valve on the domestic water riser in the crawl space. This is the recommended type of valve.

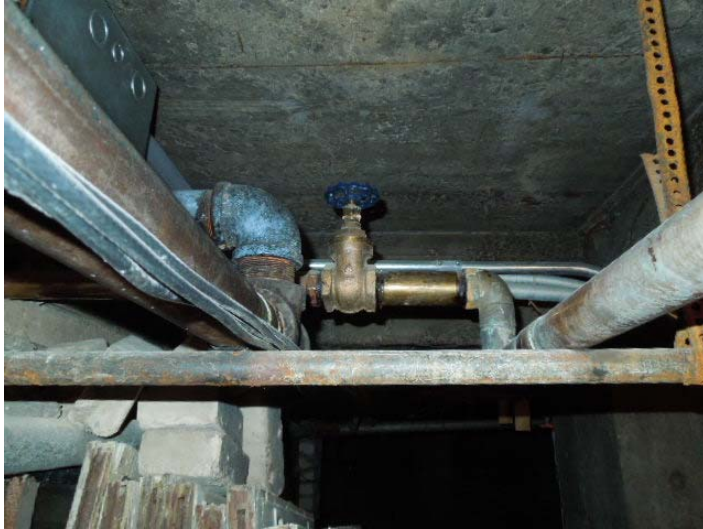
Photo #10: Typical gate type isolation valve on the domestic water riser. These valves tend not to seal for as long.

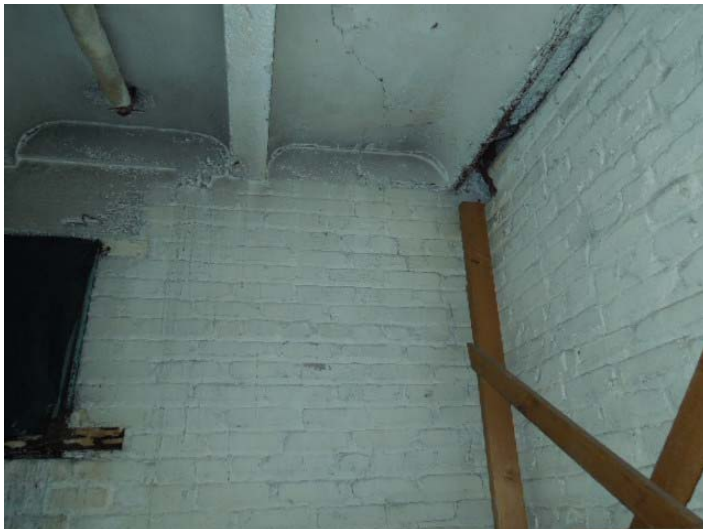
Photo #11: In the basement storage room directly off the boiler room, there is a crack in the ceiling pan aligns with a crack in the brick wall. We recommend these cracks be investigated and corrective action taken as necessary.

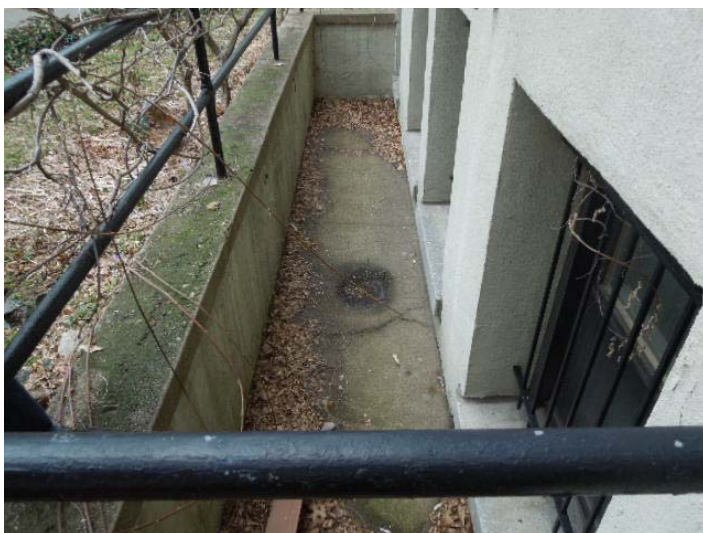
Photo #12: We recommend that the window well be cleared of leaves and debris, and that the drain be cleared so that water will not fill the well and potentially leak into the building through the windows.

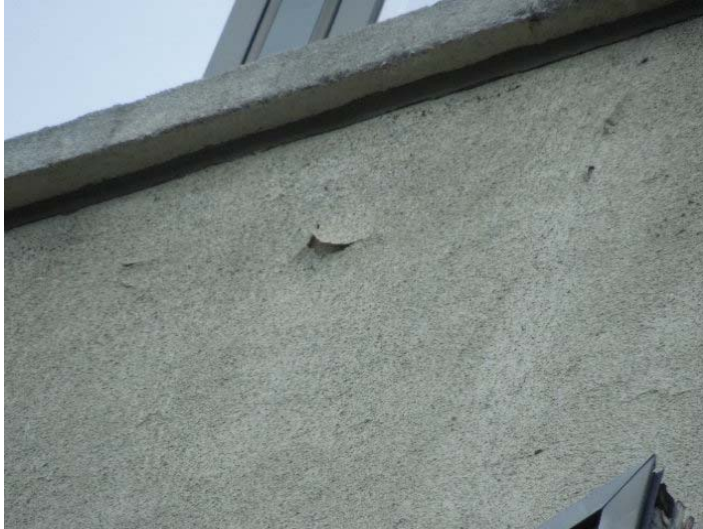
Photo #13: Stucco deterioration on south wall of building. This should be corrected to prevent further deterioration.

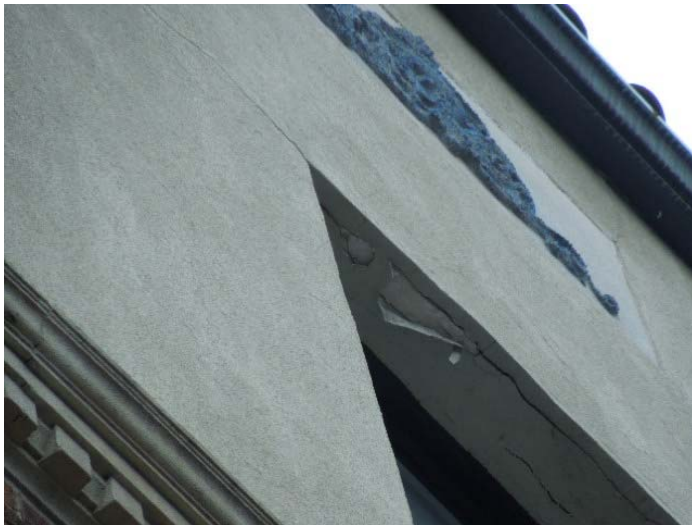
Photo #14: Deterioration of stucco over window on east side of building. This should be repaired to prevent further deterioration.

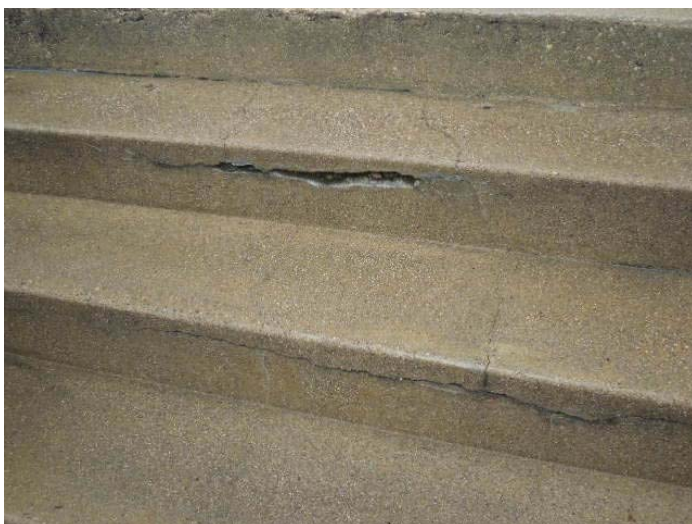
Photo #15: Opening in front steps is not aesthetically pleasing and can allow water to accumulate inside of the opening. This can freeze and cause further deterioration. We recommend this opening be repaired.
